Spiralbanding Case History

Region: Bakken region of North Dakota, USA

Drilling Contractor: Helmerich & Payne, Inc - Rig #259

Hardbanding and Inspection Services: Pathfinder Inspections and Field Services

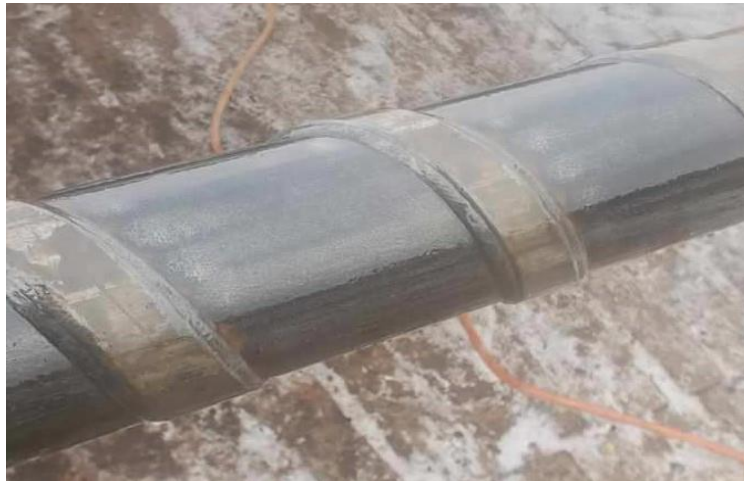
There was documented 60% wear loss in the Spiralbanding after 13 wells. Following multiple inspections, there was no documented loss in the wall thickness of the drill pipe body. Additionally, there was no evidence of cracking or spalling in the Spiralbanding. The wear displayed in the Spiralbanding performed as expected considering the pipe was not rotated top to bottom.

40% of the Spiralbanding remaining after 13 wells drilled

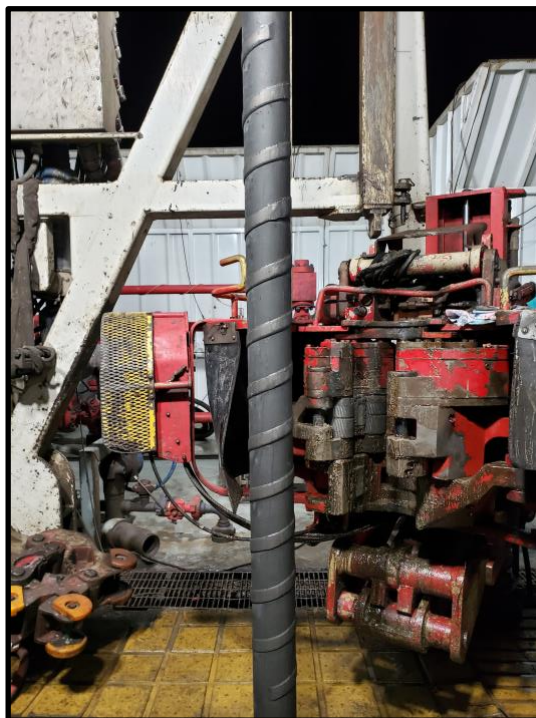
Condition of Spiralbanding after 4 wells, pictured on the rig floor
