Spiralband®NC Case History

Operator: Oil & Gas Operating Company

Drilling Contractors: Helmerich & Payne, Inc - Rig #259, Nabors Industries – Rig #X10

Hardbanding and Inspection Services: Pathfinder Inspections and Field Services

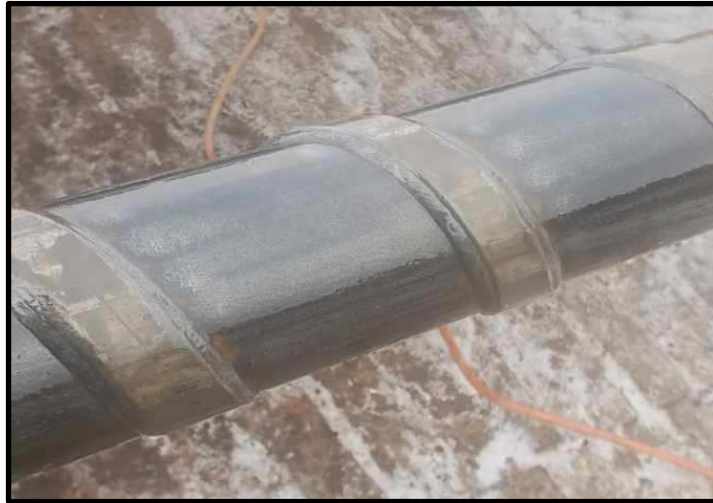
Wear exhibited by of the Spiralbanding after 13 wells drilled

The Drill pipe segments with Spiralbanding remained in specific locations at the BHA, at the agitator, and spaced in between for 8 wells. Following multiple inspections, there was no documented loss in the wall thickness of the drill pipe body. Additionally, there is no evidence of cracking or spalling in the Spiralbanding hardbanding. The wear displayed in the Spiralbanding performed as expected considering that pipe was not rotated top to bottom.

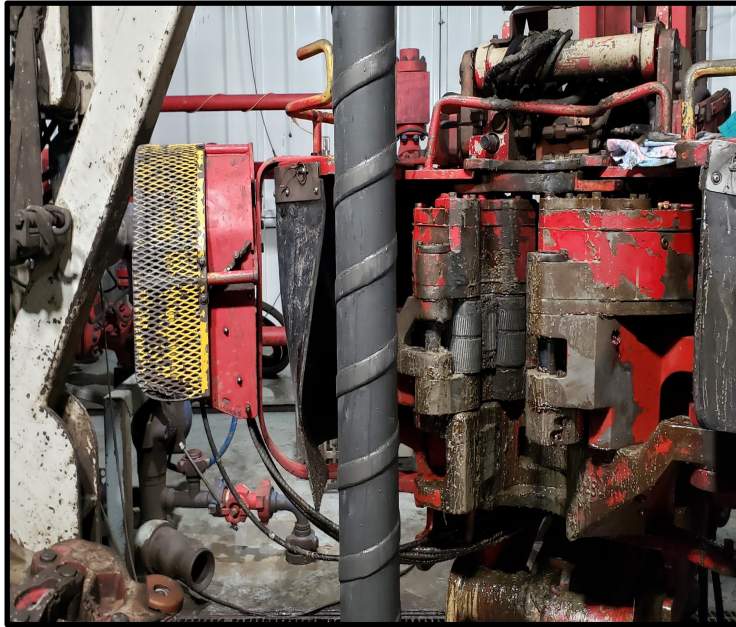
Spiralbanding condition after 4 wells drilled
